CORPS OF ENGINEERS BUFFALO NY BUFFALO DISTRICT F/6 13/2 DETAILED PROJECT REPORT AND ENVIRONMENTAL ASSESSMENT. SECTION 1--ETC(U) NOV 81 AD-A120 366 UNCLASSIFIED NL 1 of 4 40 A 120366

REPORT DOCUMENTATION PAGE	READ INSTRUCTIONS BEFORE COMPLETING FORM	
1. REPORT NUMBER  2. GOVT ACCESSION NO. A 2. 2.	3. RECIPIENT'S CATALOG NUMBER	
4. TITLE (and Subtitle)	5. TYPE OF REPORT & PERIOD COVERED	
Detailed Project Report and Environmental Assessment: Section 111, Shores East of Diked	Final	
Disposal Area, Lorain Harbor, Ohio	6. PERFORMING ORG. REPORT NUMBER

20. ABSTRACT (Critique on reverse side if necessary and identify by block number)		
A study of the impacts of the Lorain diked disposal area on the shoreline east of the area. The report found that the disposal area had not caused the total erosion problem and recommended no federal action.

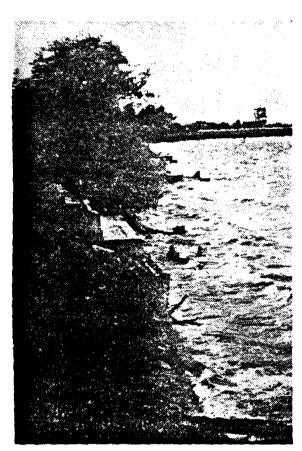
Figure 2

Shoreline at East Breakwater Shorearm Fall 1976

Shoreline at Spending Beach Revetment Spring 1978

Looking West along Shoreline toward Spending Beach Revetment October 1979

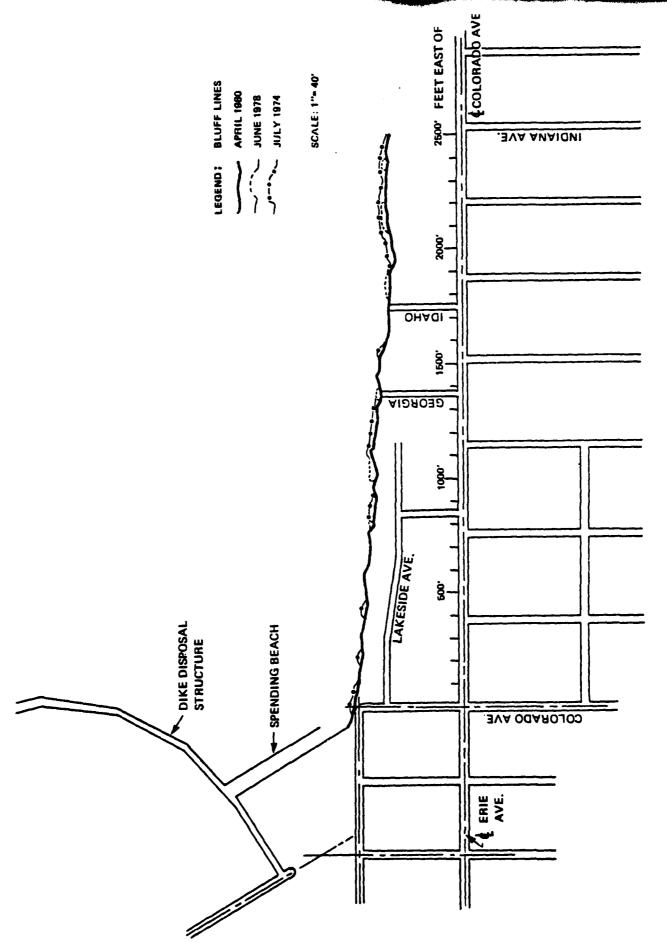
Figure 1-8 Bluff Recession From Aerial Photographs

Shoreline Increment*	Average	Pre-Di	ke Rate
0 to 50			ft/yr.
50 to 450		1.2	
450 to 950		1.2	
950 to 1950		0.8	
1950 to 2350		0.7	
2350 to 2500		0.0	
0 to 2500		0.8	ft/yr.(weighted)

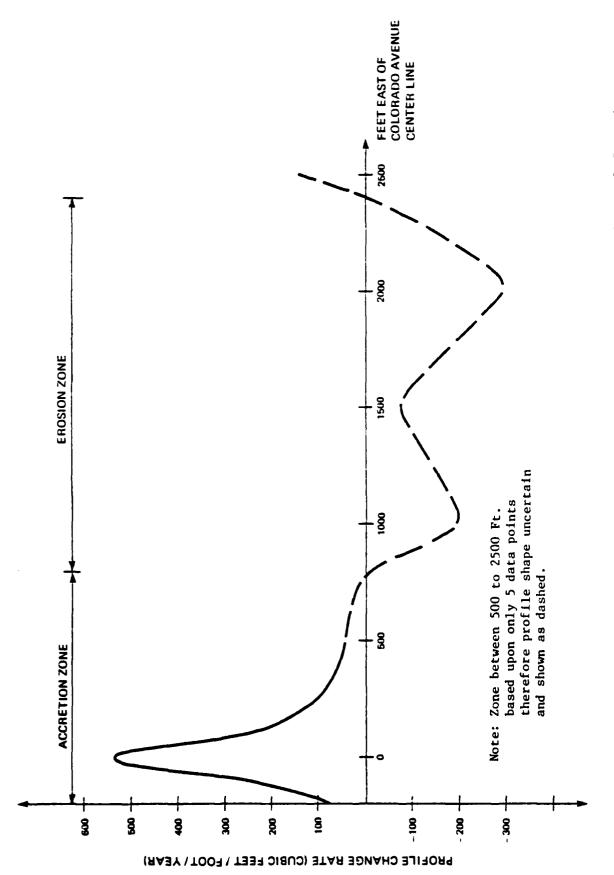
Figure 1-15 Profile Change East of Dike Disposal Structure

NOVEMBER 1977 to APRIL 1980 = 2,42 YRS
THIS PERIOD WAS CHOSEN RATHER THAN
THE ENTIRE JUNE 1974 - APRIL 1980 CE
APRIL 1975 - APRIL 1980 PERIODS ASSUMING THAT
PRIOR TO THE COMPLETION OF THE DIKE
STRUCTURE & SPENDING BEACH NO ACCRETION
FILLET AND ATTENDANT UPSTREAM ERCSION
EXISTED IN THIS STRETCH OF BEACH
IE THE ACCRETION FILLET HAS FORMED SINCE
NOVEMBER 1977

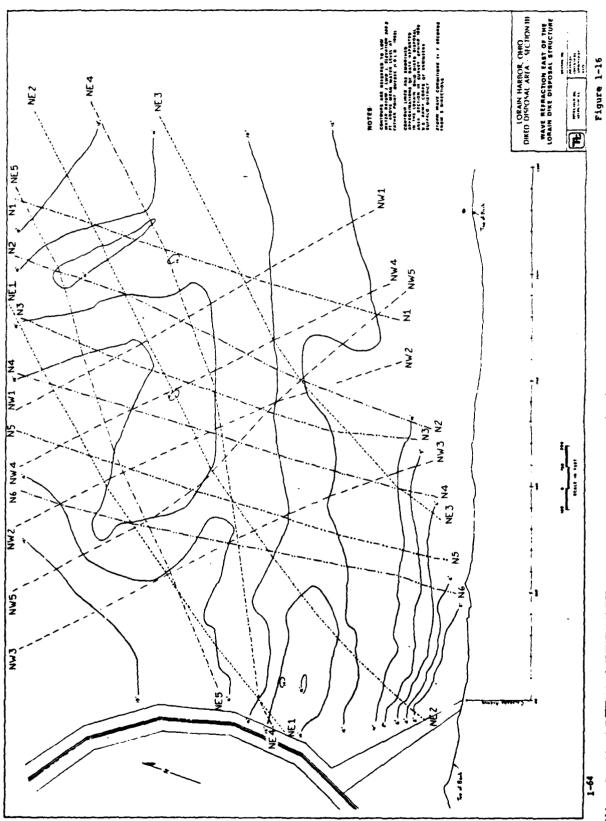
ACCRETION FILLET EXTENDS TO 800 FT EAST OF COLORADO AVE.

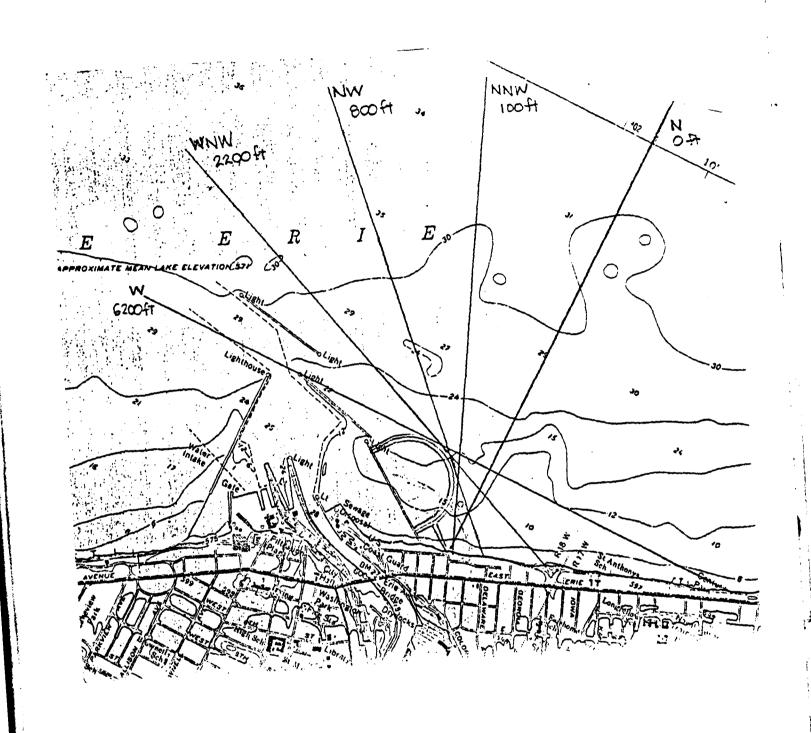
Figure 1-17
Wave Shielding Effect of Dike Structure

This shielding scenario supports the theory that the dike impounds westward littoral drift, prohibiting eastward reversals which would aid in reducing the erosion experienced on this shoreline by maintaining protective beaches fronting the bluff.
